## AMERICAN PILOTS' ASSOCIATION

### **A Request from the American Pilots' Association to State Pilotage Authorities Regarding Pilot Safety**

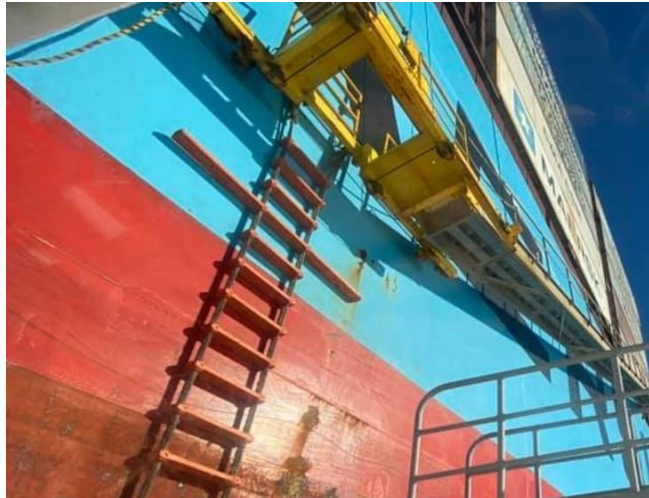
*Example of trapdoor arrangement with ladder hanging from bottom of platform*

This trapdoor arrangement is currently found on a number of ships with accommodation ladder-pilot ladder combinations, despite the facts that it has long been considered by pilots to be unsafe and that the IMO has recognized that it is unsafe by taking steps to eliminate it. Since at least 1979, IMO guidelines have recommended that pilot ladders used with a trapdoor extend to the height of the platform's handrail. The purpose of that recommended practice is to bring the ladder steps up to a level from which the pilot can step across to the platform rather than pull himself or herself up to it.

Nine years ago, the IMO revised the SOLAS pilot transfer regulation (SOLAS V/23) and its implementing guidelines (Res. A.1045) in response to continuing complaints about unsafe pilot transfer arrangements. The effective date for the new standards was July 1, 2012. Several of the revisions addressed the use of trapdoors in combination arrangements and were intended to eliminate pilot ladders that hang from the bottom or near-bottom of the platform, as well as other problems with such arrangements.

To address the pilot ladder-platform transition issue, Regulation 23 specifies that a pilot ladder “shall be rigged through the trapdoor and extend to the height of the handrail” (V/23.3.3.2.1) and, in addition, “means shall be provided to secure the lower platform of the accommodation ladder to the ship’s side, so as to ensure that the lower end of the accommodation ladder and the lower platform are held firmly against the ship’s side.” (V/23.3.3.2). Similarly, Resolution A.1045 provides that when a trapdoor is used in a combination arrangement, “the pilot ladder should extend above the lower platform to the height of the handrail and remain in alignment with and against the ship’s side.” (A.1045, paragraph 3.8).

- a. pilot ladder rigged through the trapdoor extending above the platform to the height of the handrail;
- b. lower platform of accommodation ladder secured to the ship's side, so as to ensure that the lower end of the accommodation and the lower platform are held firmly against the ship's side; and
- c. pilot ladder remains against the ship's side.
